Archaeological Excavations at Khirbet Beit Bassa, Palestine

Ibrahim Mohammad Abu Aemar

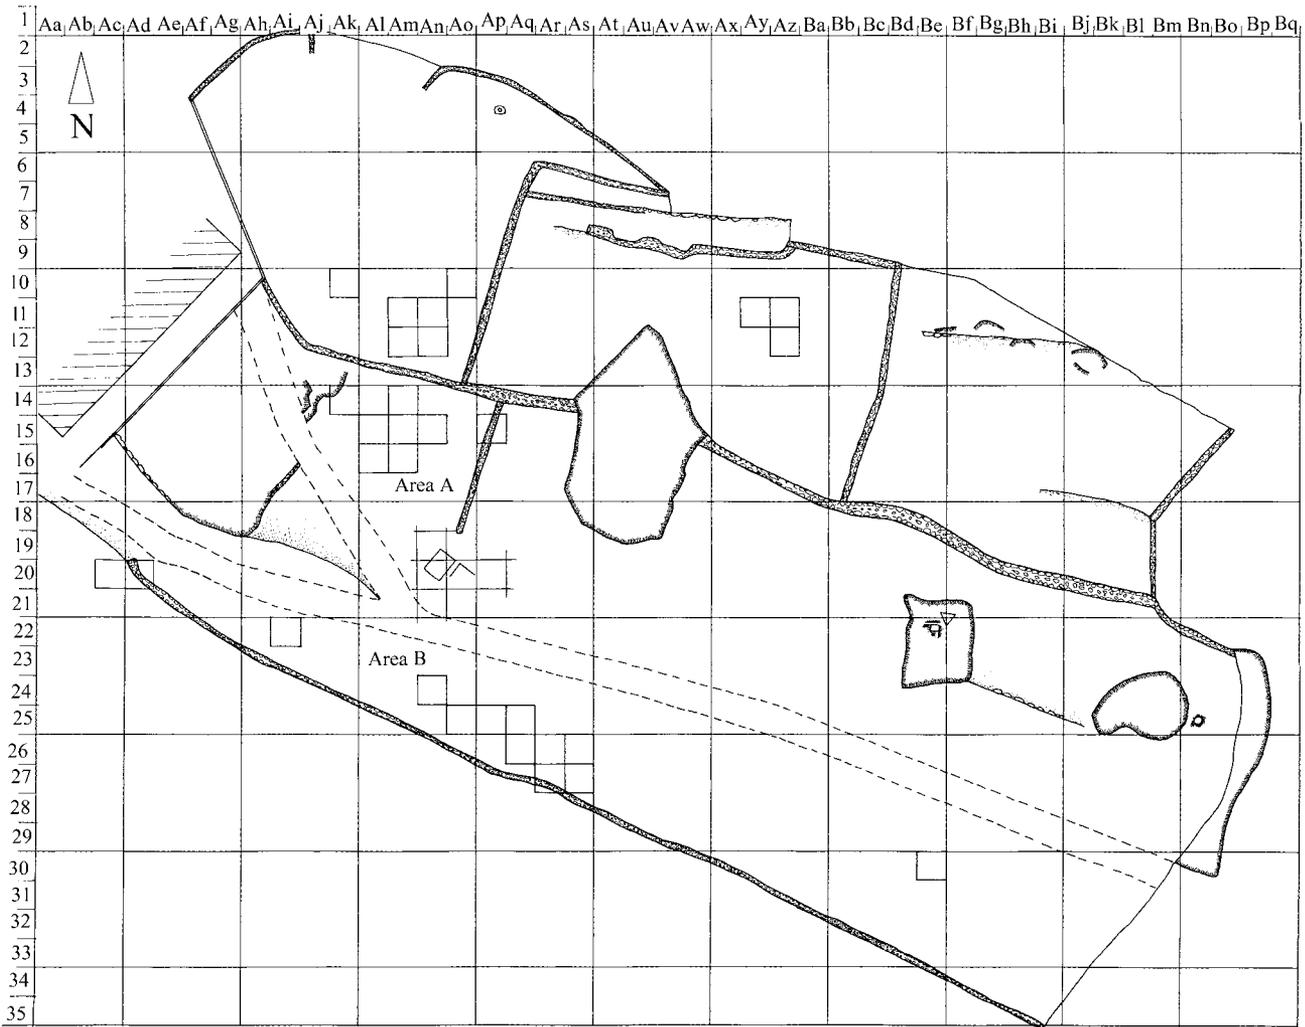
Figure 2. Site plan of Khirbet Beit Bassa. Drawing by Ibrahim Iqtait.

Before the team embarked on the first archaeological excavation season, we carried out a network mapping of the site. Its area was divided into numerous excavation squares, each measuring 5×5 m, and each square was given a name that consists of two letters and a number (fig. 2). An unexcavated margin of 50 cm was left around each square (i.e., 1 m balks) for short-term preservation of the stratigraphic profile, while also allowing movement of the team throughout the site. In addition, for

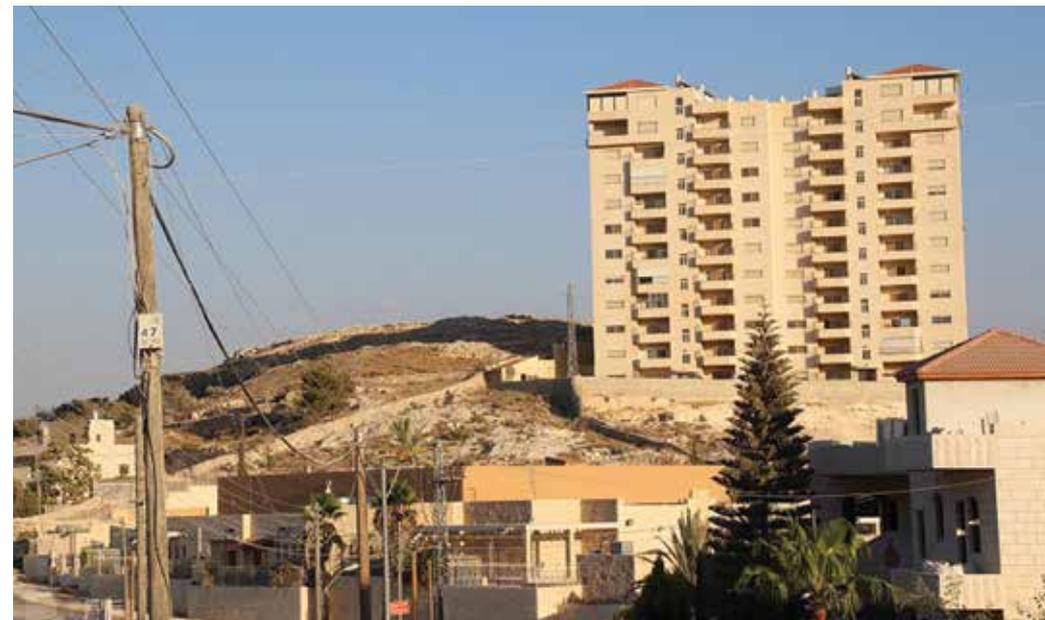
Figure 3. Al Taweel building in the west part of the Khirbet Beit Bassa. Photograph by the author.

carried out in search for precious cultural materials. Furthermore, the construction of a 5 m-wide road through the middle of the *khirbet* and other works of urban development have caused serious damage to the site. One of the most blatant intrusions was committed by one of the land owners in 1994, when he built a large residential structure in the western part of the site without first obtaining a permit. This edifice, known as the Al-Taweel Building, consists of twelve floors, each with four apartments. In addition to the physical damage caused by the construction, this building has obscured the westward vista from the hilltop site (fig. 3).

Based on previously collected information, a winepress and part of the *khan* were located where this building now stands. The Palestinian Ministry of Tourism and Antiquities arrested the owner of this building for causing damage to the site and held him for fifteen days, but in the end it issued the required permits.

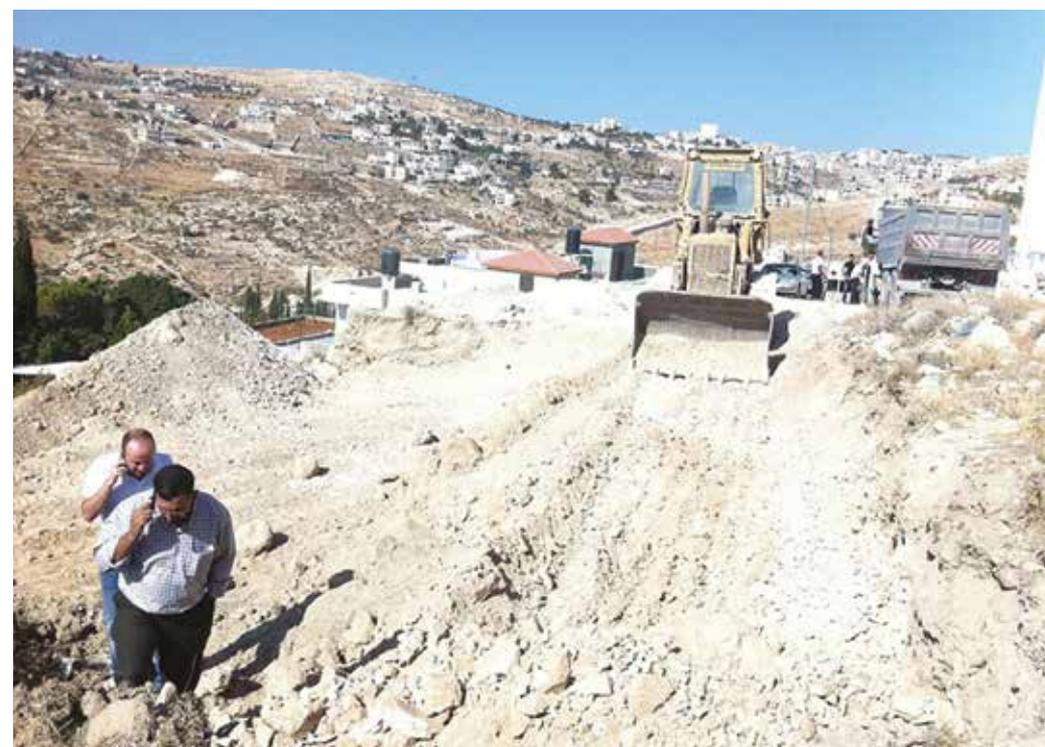
Figure 4. External wall destruction by a bulldozer. Photograph by the author.

The most recent encroachment on the site was committed in 2014, when another land owner bulldozed his property using heavy machinery, again without first obtaining a building permit. As a result, parts of the ancient defensive wall that surrounds the site was demolished (fig. 4), not to mention the destruction of the related archaeological layers with their cultural materials.

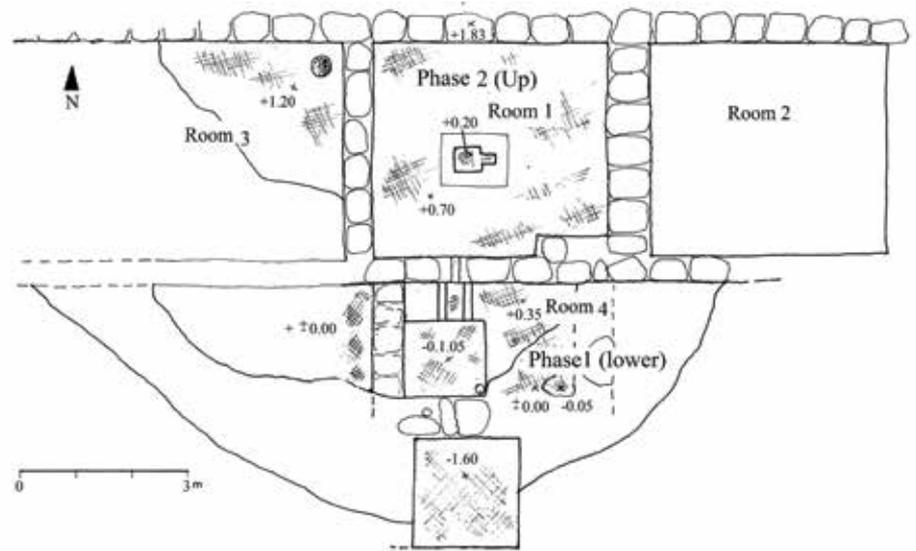
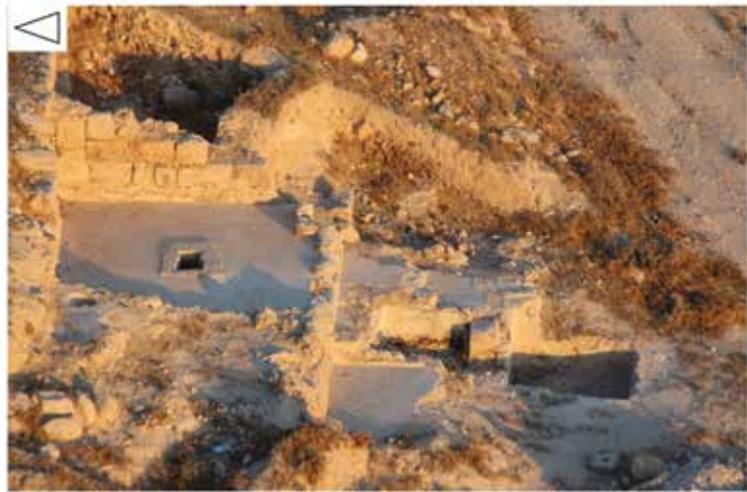
Figure 6. The winepress. Drawing by Ibrahim Iqtait; photograph by the author.

discovered in 2008, a smaller section was excavated by the author in 2015. The winepress consists of four rooms, and is part of a large complex in which one room contains two rock-hewn vats. Based on architectural evidence, this winepress has undergone two structural stages.

The first (and most recent) section consists of a pressing basin, located in a room (Room 1) that is flanked by two side rooms (rooms 2 and 3). The pressing/treading process was carried out in this central room that measures 4.20×3.80 m. The remains of the walls are built of cut stones of different sizes that are laid as regular horizontal courses and set with mortar. The extant height of these walls rises to 1.5 m. The basin's floor is paved with plain white tesserae, and there is a pierced, rectangular stone block set in the middle, slightly raised above the level of the surrounding mosaic. The stone has a carved hole in the center, measuring $35 \times 60 \times 40$ cm, which served as a socket to fix the wooden column that was once used in the pressing process.

From the middle of the southern wall of the pressing basin (Room 1), a 1.2 m long and 15 cm wide channel—built from medium-sized stones and coated with a layer of plaster that is mixed with small stones—leads to the rock-hewn vat where the juice was collected (Room 4), located directly south of Room 1. The older, original elements of the winepress are immediately evident in Room 4. The northern section of this room was discovered intact; the southern part, however, had mostly been destroyed during the 2008 construction of the road that cuts through the site. The dimensions of the surviving parts of this room are 3.6 m east–west and 4.3 m north–south. The wall construction is similar to that in Room 1. Here, however, there are two mosaic floors,

one above the other, which indicates two distinct structural phases. The upper mosaic floor consists of white cubes that are laid out over three layers that consist of (from top to bottom) a mortar matrix, a stone pavement, and a deposit of soil mixed with medium-sized stones. The surface of the upper mosaic floor lies about 35 cm below the floor level of the adjacent treading basin, and the older mosaic floor lies approximately 35 cm below the level of the upper mosaic floor. Similar to the upper mosaic, the lower mosaic consists of white stone cubes, but these are smaller than those of the upper level. The most recent collecting vat in Room 4 is located in its northern part, square in shape (1.5×1.5 m), and 1.05 m deep; it is carved into the natural bedrock and contains remains of a 5 cm thick layer of plaster on the internal walls. Based on our manual analysis in the field, we found that this plaster layer consists of lime, natural and artificial aggregation, charcoal, pottery sherds, and grog.

in the construction of Rooms 1, 2, and 3. The older collecting vat is carefully carved into the natural bedrock, with dimensions of 1.85×1.85 m, at a depth of 1.55 m; its walls are coated with lime plaster, and its floor is covered with white mosaic as well.

Based on the analytical study of the architectural remains of the winepress, we can argue that its construction went through two distinct structural phases. The oldest phase included only Room 4, which contained a mosaic-paved treading floor and the southernmost juice-collection vat. During the more-recent, second structural phase, an enlarged winepress facility was built that reused the older space (Room 4), but added a new collection vat and pavement, and furthermore expanded also structurally to include the three rooms to the north: Rooms 1, 2, and 3 (fig. 6)

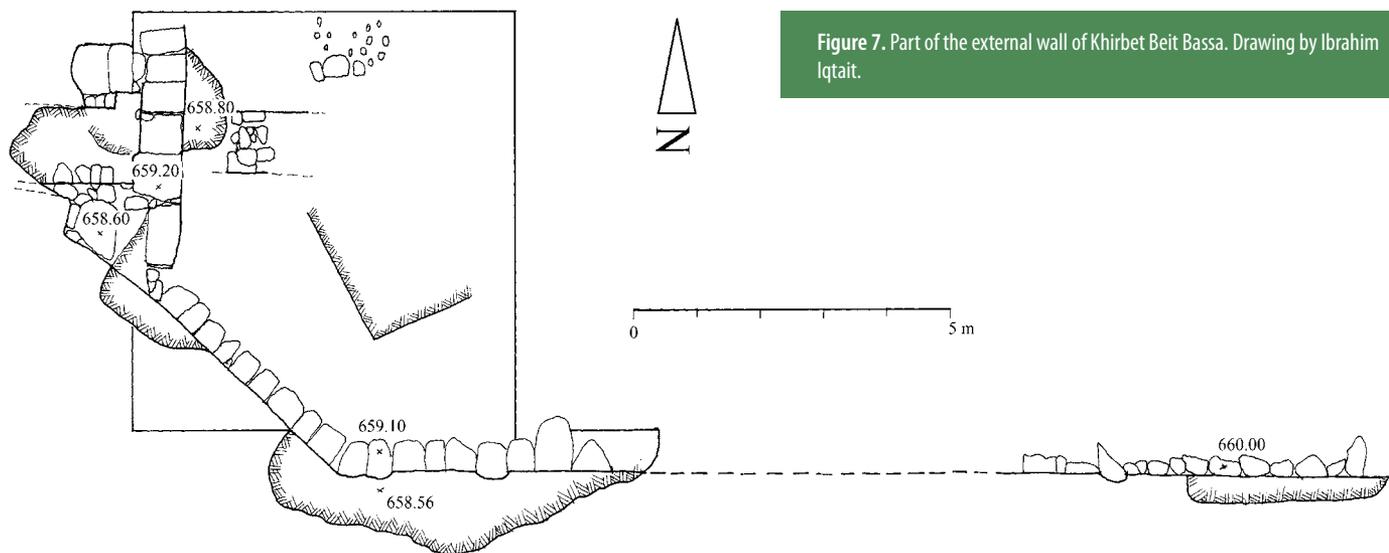
Figure 7. Part of the external wall of Khirbet Beit Bassa. Drawing by Ibrahim Iqtait.

The excavations in this area brought to light first, an east-west oriented wall segment that had survived to a height of only one course, built directly on the bedrock. It appears in three squares, where the remains of a possible tower, attached to the outer part of this wall, have been found. The thickness of the wall reached approximately 1.3 m, and the total length of its angled three segments was approximately 12 m. It was built with stones of various sizes and shapes—except for the possible tower, which was constructed with regularly shaped stones. In the excavation to the east, a continuation of the east-west wall segment was found, showing the same construction method and type of stones. This wall, which was subsequently strongly affected by agricultural activities, marked the southern limit of the excavated area. In 2014, the owner of the land on which

the wall had been discovered proceeded to bulldoze a wide area of his land, including the remains of the wall extension. He was prevented from further work after I visited the site. After obtaining permission from the Palestinian Ministry of Tourism and Antiquities, I then conducted a salvage excavation in the recently affected area, in which I found the wall's natural extension to the northwest (fig. 7).

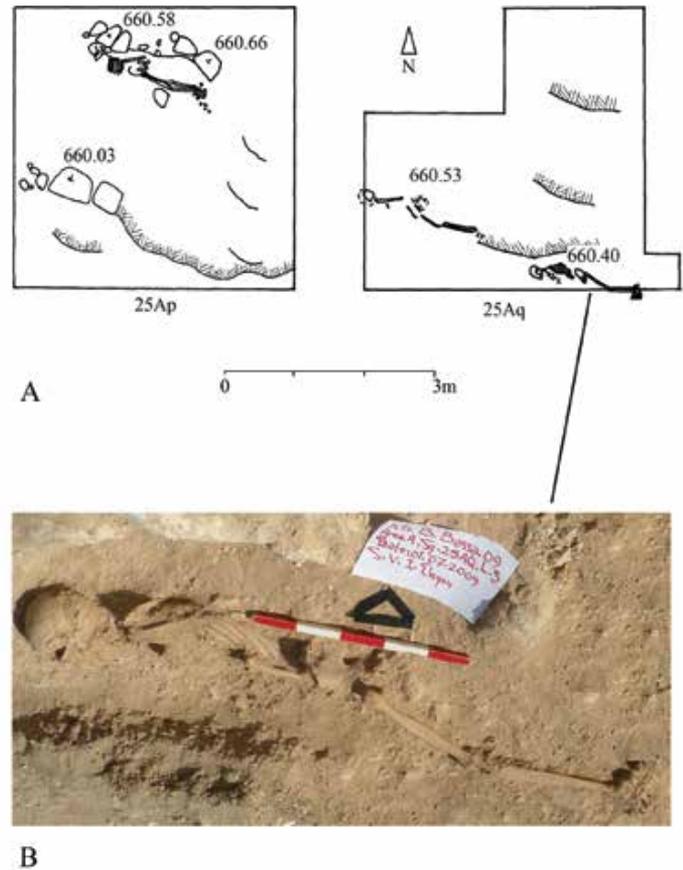
Figure 8. A: Graves exposed; B: One of the skeletons from the Muslim cemetery. Drawing by Ibrahim Iqtait; photograph by the author.

In addition, three ground graves were discovered. Two of them were found in square 25AQ, and the third in square 25AP. The first grave, which had been carved into the natural bedrock surface, was discovered in the southeastern part of square 25AQ and was 2 m long × 80 cm wide × 60 cm deep. The second grave was found near the first grave in the same square, to the northwest, and shows the same characteristics. The third grave was found 3 m northwest of the second grave, and it differs from the other two in that it was built *upon* the bedrock using medium-sized stones, rather than being a rock-hewn feature. Graves 1 and 3 were found intact, without any damage, while Grave 2 had been partially destroyed. A single skeleton was found in each of the three graves, with the bodies oriented east-west and devoid of any funerary attachments. Further, in each instance the head was directed toward the west, and the face turned toward the south (Mecca). Based upon these orientations—of the graves themselves and the heads and faces of the

interred—we can conclude that these burials belong to a Muslim cemetery (fig. 8).

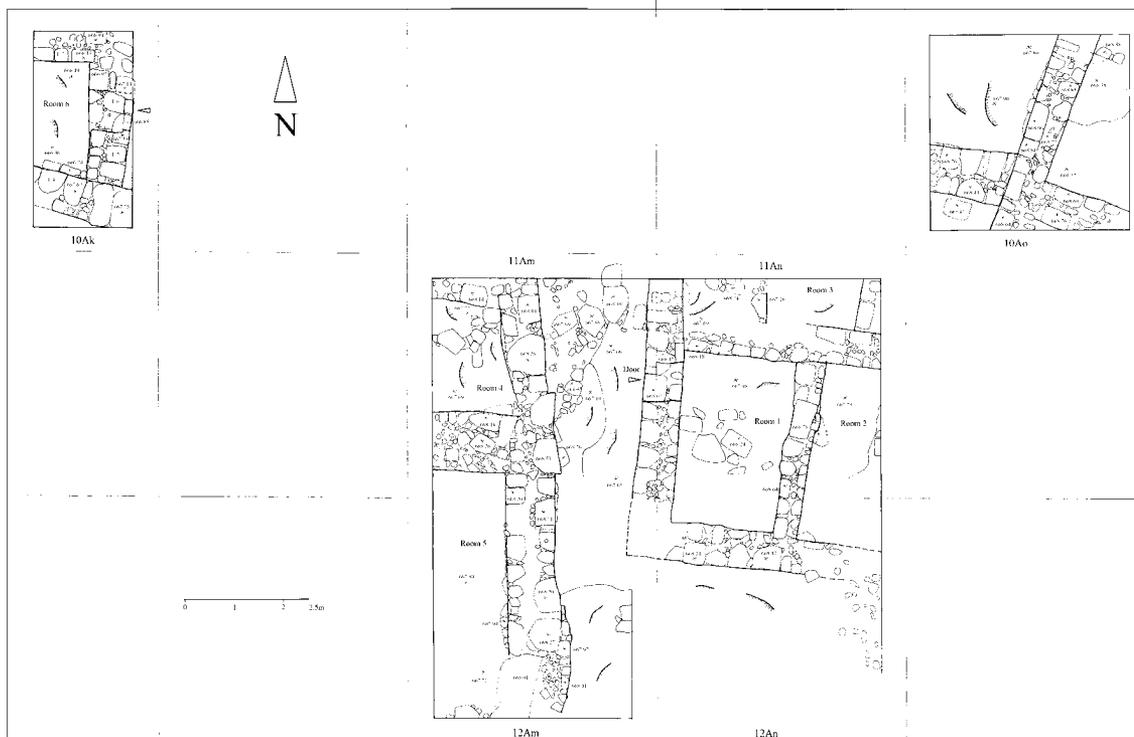
Figure 9. Residential area. Drawing by Ibrahim Iqtait.

In 2010, a residential building was discovered consisting of five rooms, separated by an internal central corridor. The eastern part of the building comprises three rooms: The main room (Room 1) is rectangular, with internal dimensions of 2.15 m × 3.5 m. The western wall has a doorway that is 80 cm wide. The maximum surviving height of this room's walls, built of regularly shaped stones, is 90 cm. It is obvious that originally there was also an entrance in the eastern wall of Room 1, which was blocked at some later time. It is likely that the three eastern/northeastern, partially unearthed rooms were reused during the Umayyad period, since part of a pottery oil lamp belonging to that era was found in an undisturbed layer associated with this wall. The blocked doorway leads to Room 2 (to the east of Room 1), with internal dimensions of 3.7 m long × 1.5 m wide, at least. Room 3 is located to the north of Room 1, and is partially excavated.

In the northeast corner of area B three intersecting walls were discovered that probably represent a cluster of service rooms. A partial oven was found in the southwestern part, while on the eastern side of the main north–south wall a damaged plaster floor was documented, probably once the bed of a mosaic pavement (figs. 9, 10).

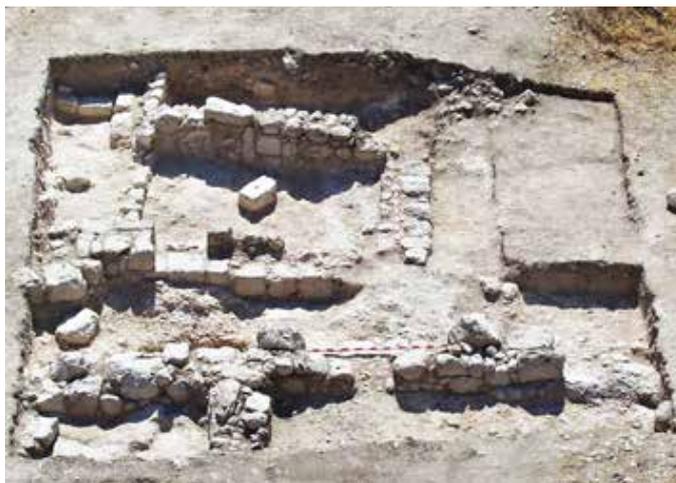
Figure 10. Photograph of the residential area. Photograph by the author.
